Manhole Inspection Summary

Manhole # S06AA2010MH

Insp Date: **7/12/06 7:29 AM**

Location Address: **4001 FALLSTAFF RD**

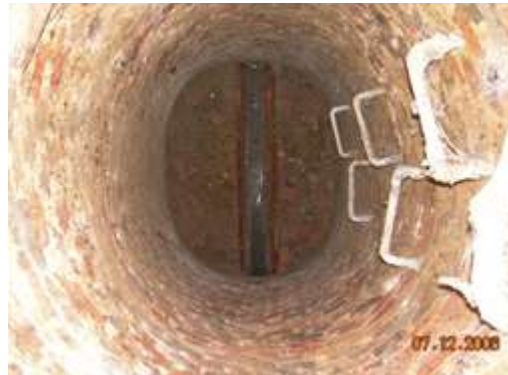
Top View

Adjustment and Barrel infiltration.
Evidence of surcharge - Bench debris.

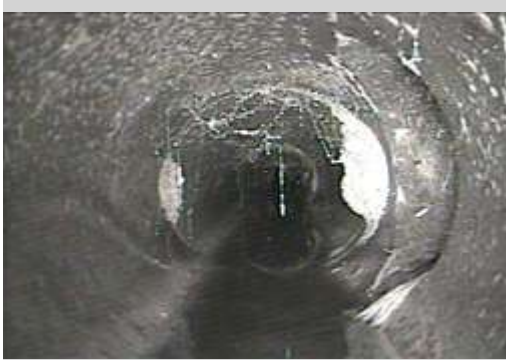
Inside the I6

Root intrusion.

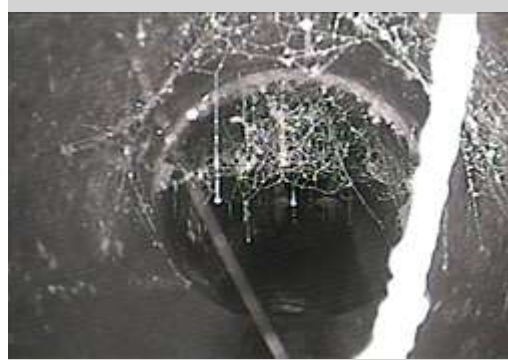
Inside the O12

Root intrusion.

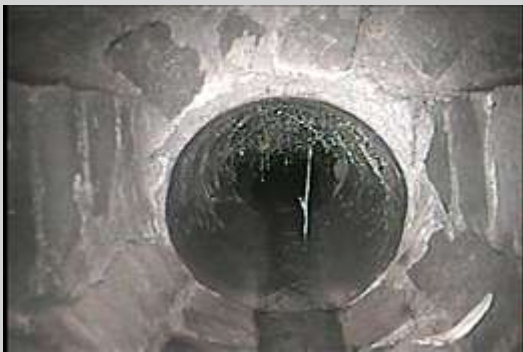
8 in. Circular Gravity Sewer Pipe Out @ 12 O'Clock

Deposits: ☒ None ☐ Mud ☐ Sludge ☐ Debris ☐ Grease

Infiltration: **None** Pipe Seal Cond: **Unknown**

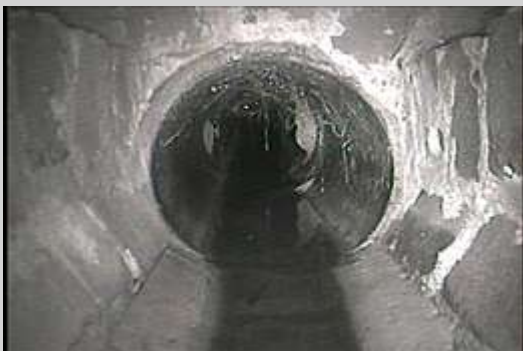
8 in. Circular Gravity Sewer Pipe In @ 6 O'Clock

Deposits: ☒ None ☐ Mud ☐ Sludge ☐ Debris ☐ Grease

Infiltration: **Evidence** Pipe Seal Cond: **Unknown**
